# BOEING 757 INAPPROPRIATE CREW RESPONSE TO UNRELIABLE AIRSPEED CAUSES INJURIES AND DAMAGE

News / Airlines

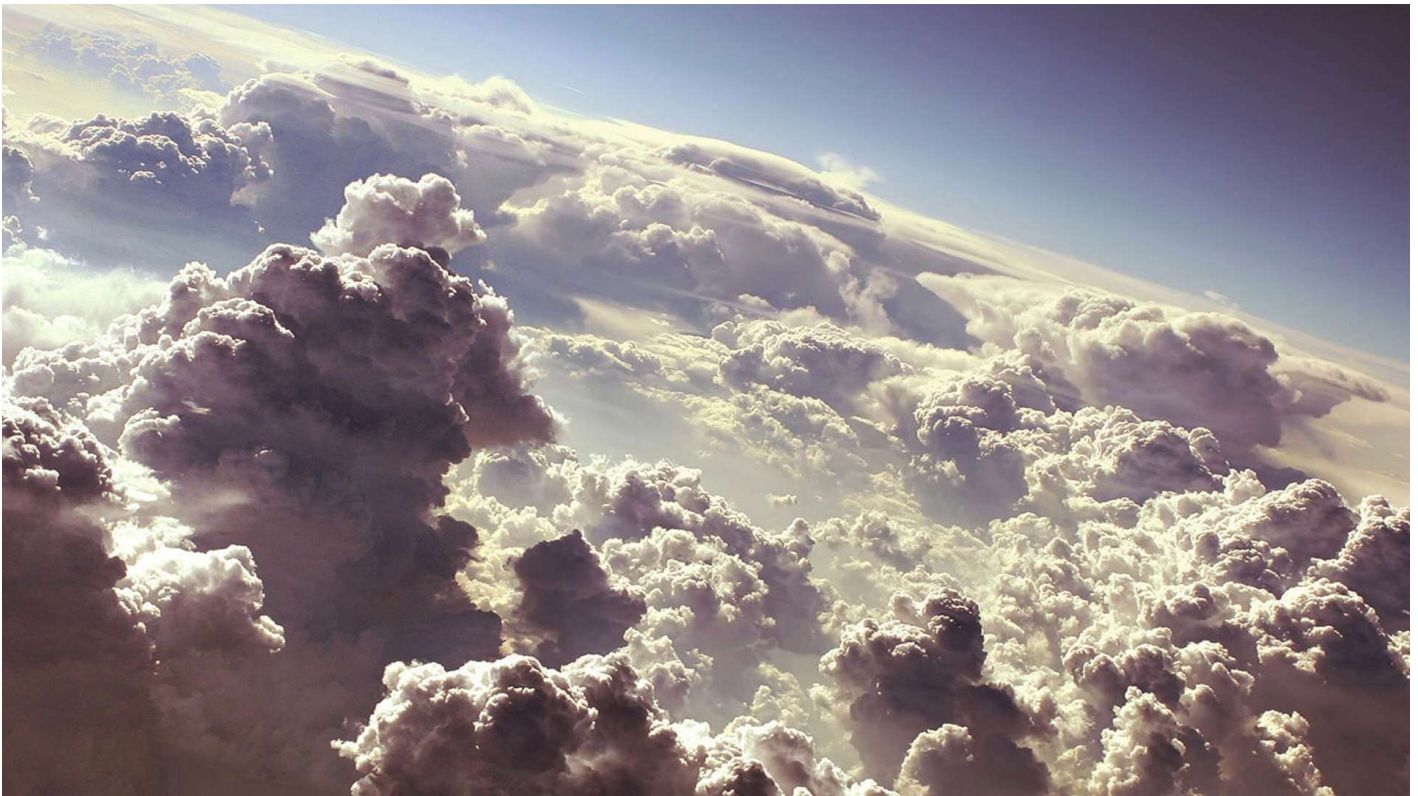
**Damage to service bay and associated structure (AAIU)**

The commander advised ATC that they had encountered severe turbulence and that medical assistance was required on arrival because some passengers had been injured. In addition, the Airport Fire Service was also requested to be in attendance on landing due to the loss of the centre hydraulic system. A normal landing was performed at Dublin, without further incident. On inspection it was found that the aircraft had sustained significant damage.

- Temporary blockage of the right main pitot probe due to ice crystal icing, leading to an unreliable airspeed indication.
- Non-standard Flight Crew response to a low airspeed indication.
