# CORROSION WARNING FOR BELL 429 OPERATORS

News / Manufacturer

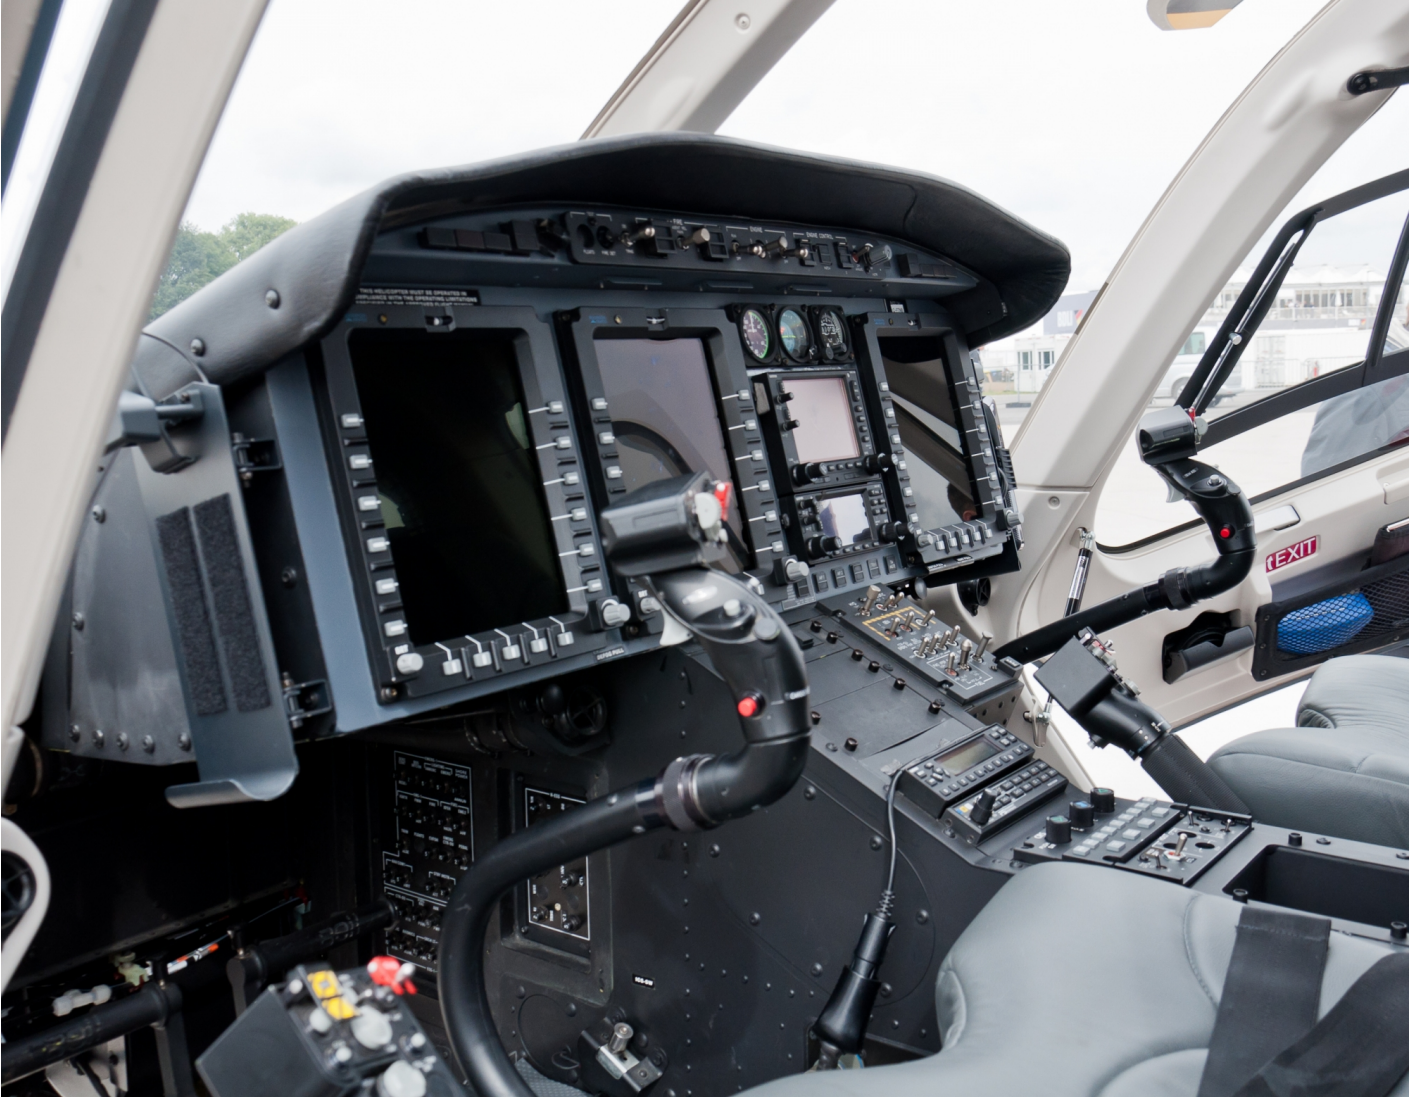
**Operators of Bell 429 helicopters have been instructed to conduct urgent inspections of a tail rotor component after an investigation revealed a potentially dangerous manufacturing defect.**

In an emergency airworthiness directive (EAD) effective from 19 January, certification agency Transport Canada warns that corrosion on the part could lead to its failure and subsequent loss of control of the aircraft.

Its warning comes after an in-flight failure of a tail rotor pitch link on a 429. This caused “noticeable vibration” and “difficulty controlling the helicopter”, says Transport Canada.

A subsequent investigation revealed that the pitch link had fractured, with a crack originating at a corrosion pit.

“Further investigation revealed deficiencies in the application of corrosion resistant finishes to the pitch link during the manufacturing process,” Transport Canada says.

Operators are mandated to inspect affected pitch links for signs of corrosion and replace them as necessary.
